BEK122

Balance Shaft Elimination Kit Instructions

BEK122 - Chrysler/Mitsubishi 1.8L, 2.0L, 2.4L,
G62B, G63B, 4G63B, G64B, 4G64B
(belt drive applications)

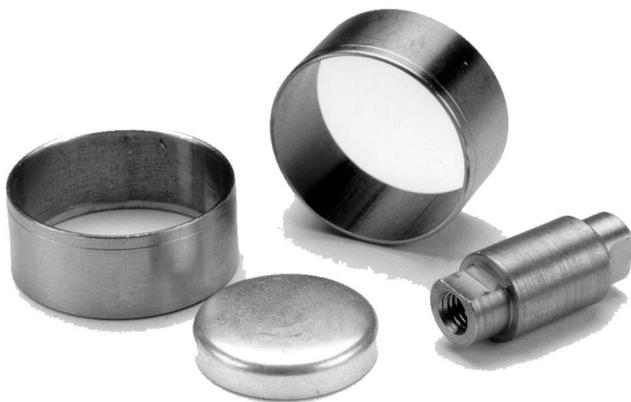
2. Install the oil pump through the driven gear (see figure 1). Use the lower balance bolt to secure the plug drive oil pump gear. Tighten using thread locker or equivalent to 25-29 ft. lbs. torque. The squared end of plug may be held in a vice to assist in tightening to the proper torque.

CAUTION: The driven gear plug must be tightened with the correct torque to prevent the plug from loosening and damaging oil pump. NOTE: After tightening, rotate pump checking for resistance. If resistance is felt, rear case thickness can be filed for clearance.
